NASA TECHNICAL MEMORANDUM

NASA TM X-64901

PERFORMANCE OF SOLAR SHIELDS

By Robert J. Schwinghamer
Materials and Processes Laboratory

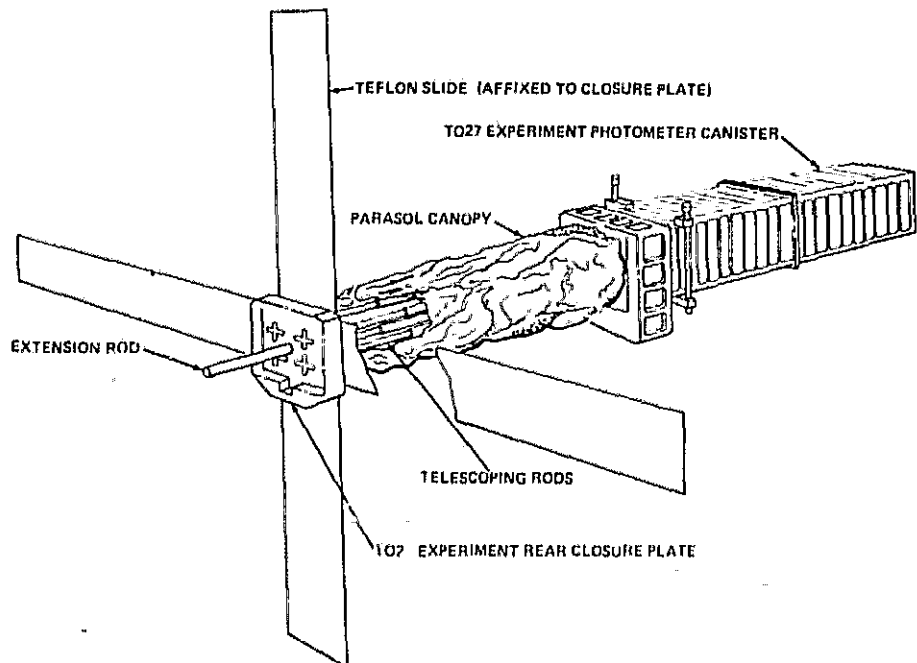
Figure 2. JSC parasol general packing arrangement.

The general packing arrangement can be seen in Figure 2. An existing TO-27 canister was employed.

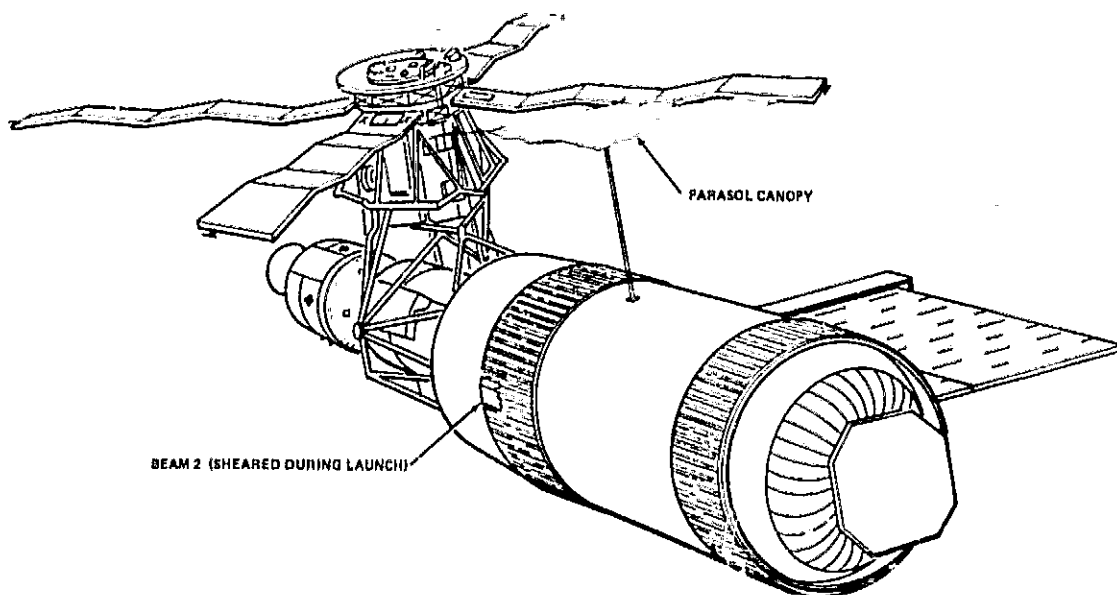
Figure 2. JSC parasol full extension and full deployment.

The canopy rods were projected to the maximum height of 7.3 m (24 ft.) above Skylab (Fig. 3). At this point the parasol deployment was completed, and the retraction to the final position near the OWS skin had not yet occurred.

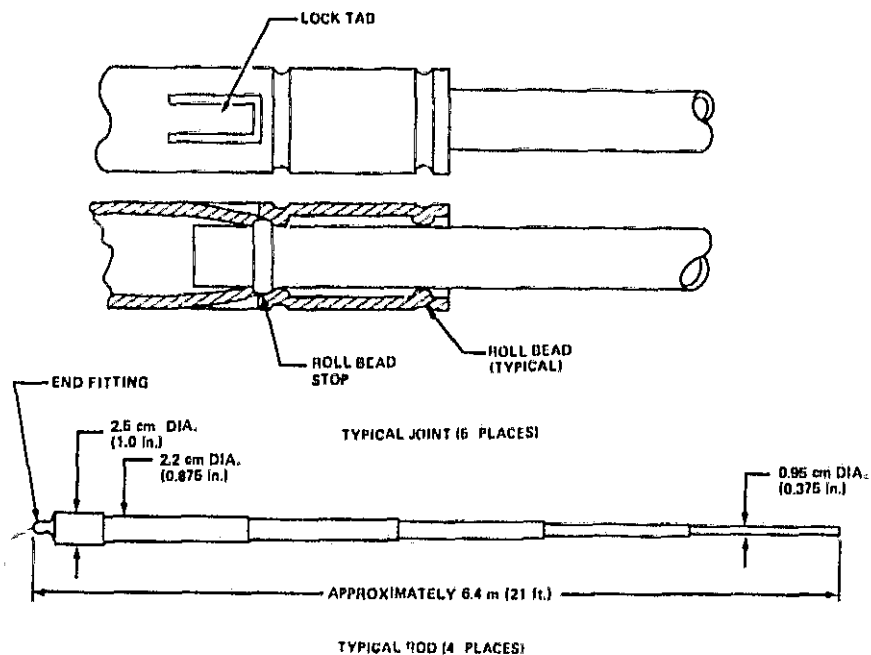
Figure 4. JSC parasol telescoping tube design.

A sketch (Fig. 4) of the unique telescoping tube locking mechanism which projected the corners of the 6 by 7.3 m (20 by 24 ft.) parasol is shown. The material used was 6061-T6 aluminum.

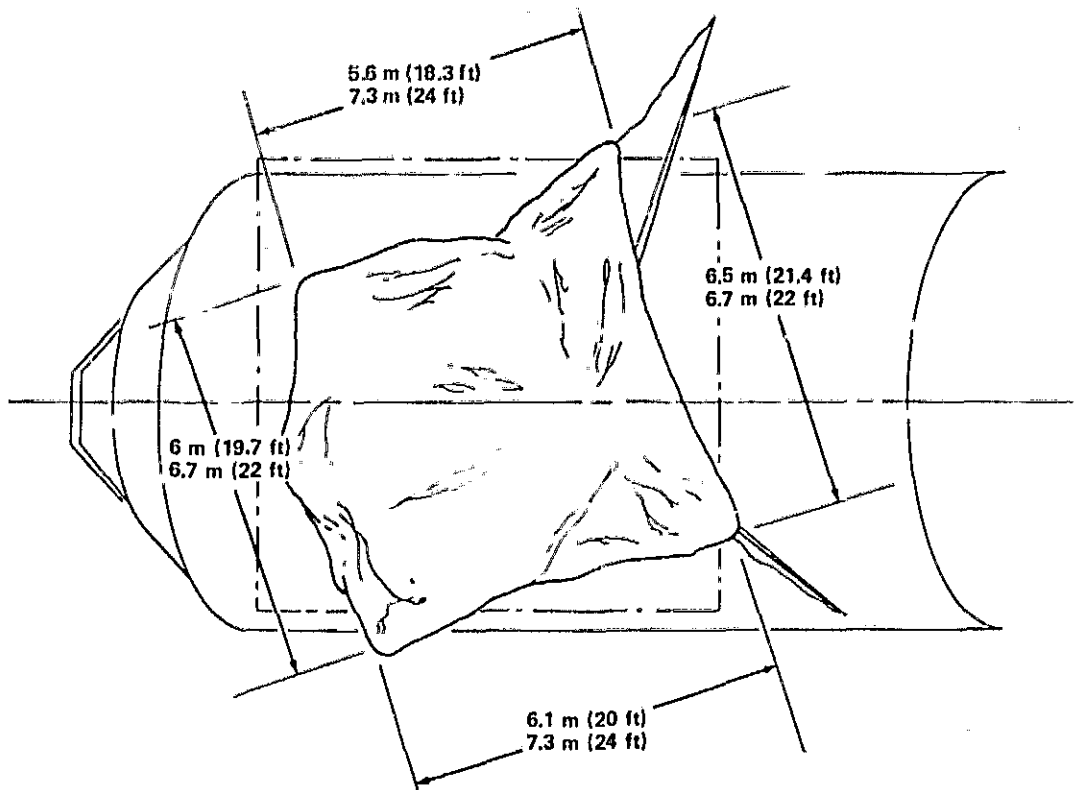
Figure 6. JSC parasol coverage comparison (actual vs. planned).

parasol to the original position, they did so, and no further attempts to use the rotation design feature of the parasol were ever made. The sketch (Fig. 6) shows the planned versus the actual coverage attained by the parasol.

After the JSC parasol was deployed on May 27, 1973, the internal temperatures decreased 16.7°C (30°F) in two days. The crew, however, observed that the shield did not completely open, and a day after the deployment, flight data began to differ from that predicted analytically by the thermal model. During the SL-1/SL-2 storage period the temperature reached 36.7°C (98°F) during a high Beta angle period. During departure of Skylab II crew, fly-around photos confirmed that the actual shade coverage was only 75 percent (Fig. 6).

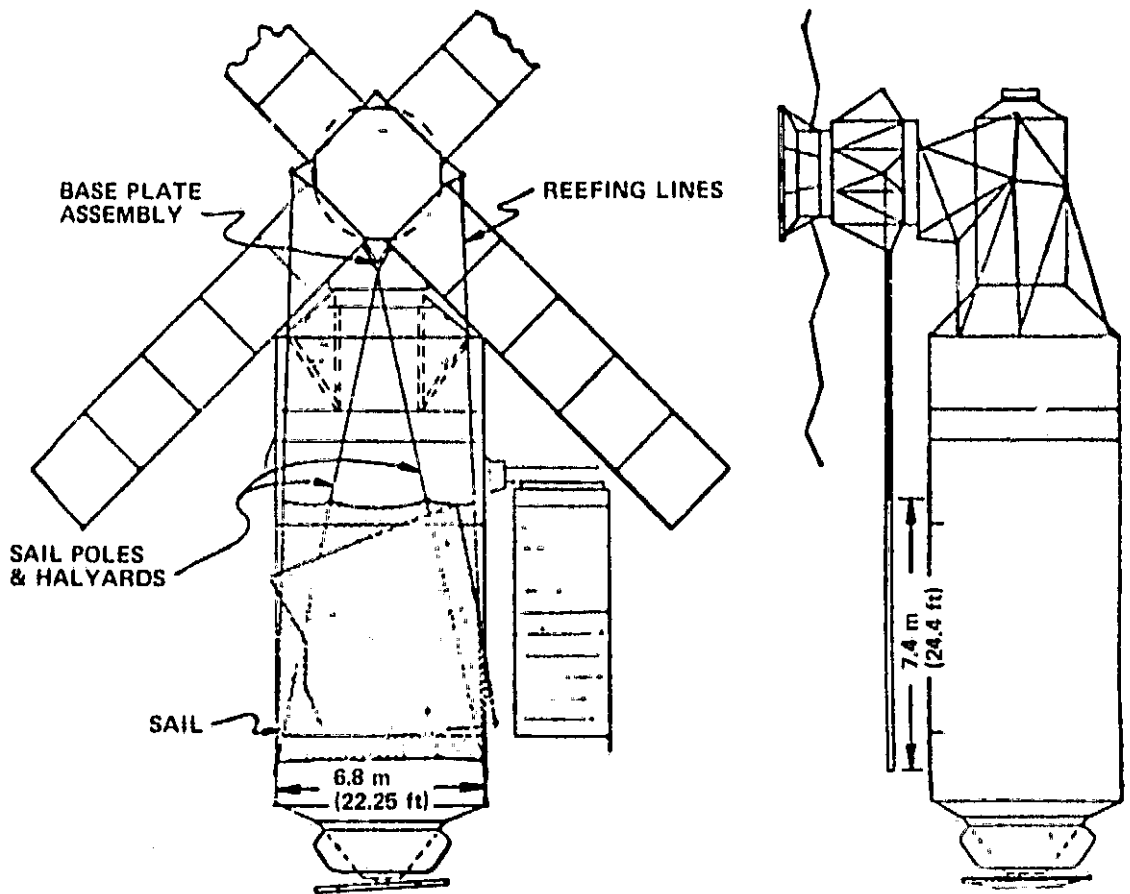
Figure 7. MSFC SAIL II arrangement.

The MSFC SAIL II hardware included twenty-four 6061-T651 aluminum pole sections, each 1.5-m (5-ft.) long, which when coupled, provided two poles 16.8-m (55-ft.) long. Each pole connection had a twist lock arrangement featuring an extremely low temperature silicone "O" ring (SE-5211) which

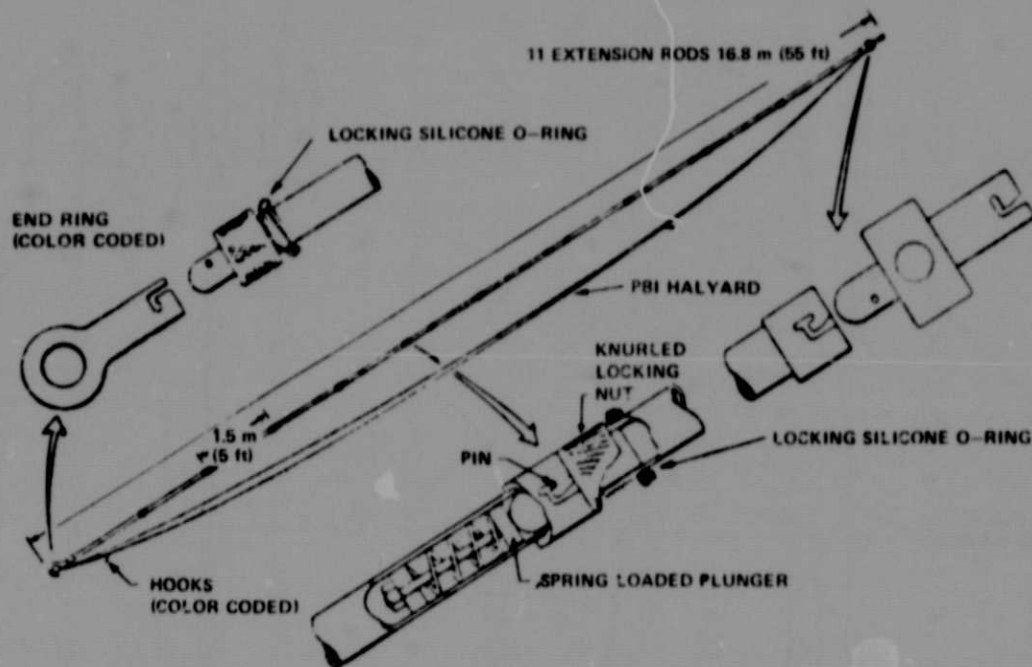
Figure 8. SAIL pole design details.

Design details of the SAIL poles are shown in Figure 8. In testing, it was found that the knurled nuts tended to back off and work loose. Special locking O rings were designed and manufactured to prevent this.

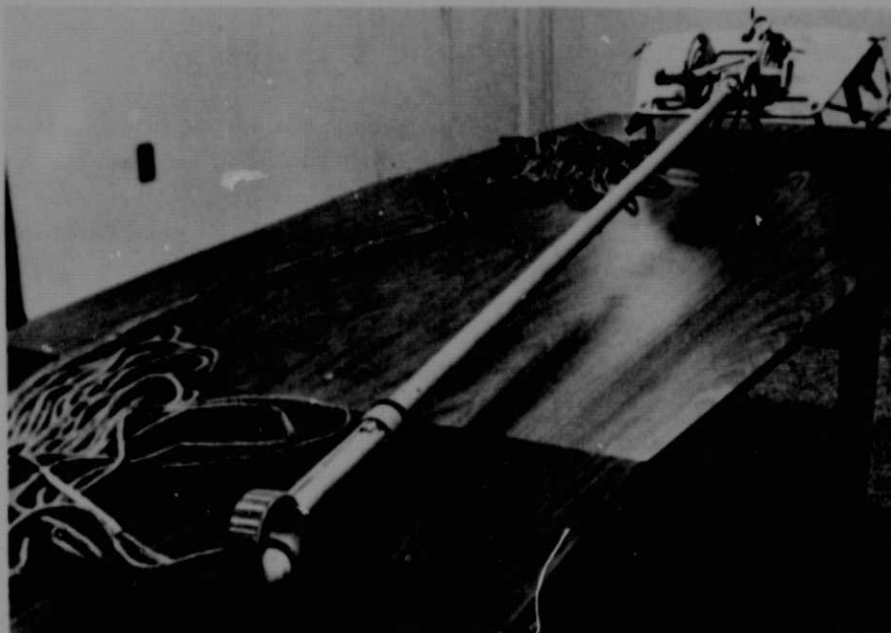
Figure 9. MSFC SAIL II pole baseplate with typical pole section, pole end-eye and PBI halyard rope.

The pole baseplate (Fig. 9) shows only one of the pole sections inserted. A typical eyed-end fitting and the PBI halyard rope can be seen in the foreground.

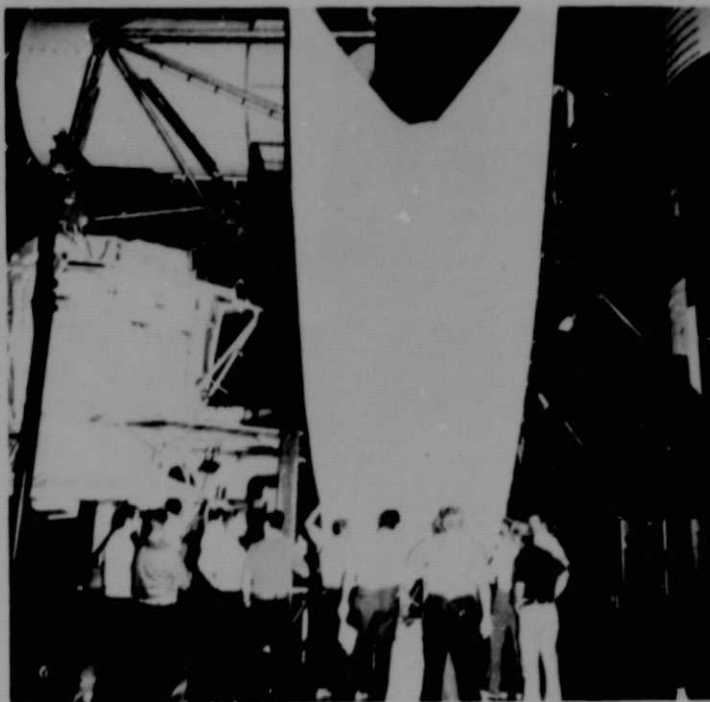
Figure 13. Final backup SAIL deployment and Skylab II crew training exercise.

A full scale deployment test (Fig. 13) was conducted at MSFC. This was the final check on a backup SAIL to determine positively that there would be no sticking of the thermal control surfaces during deployment. This was also the final deployment orientation session for the Skylab II crew, who finally deployed the SAIL on Skylab.

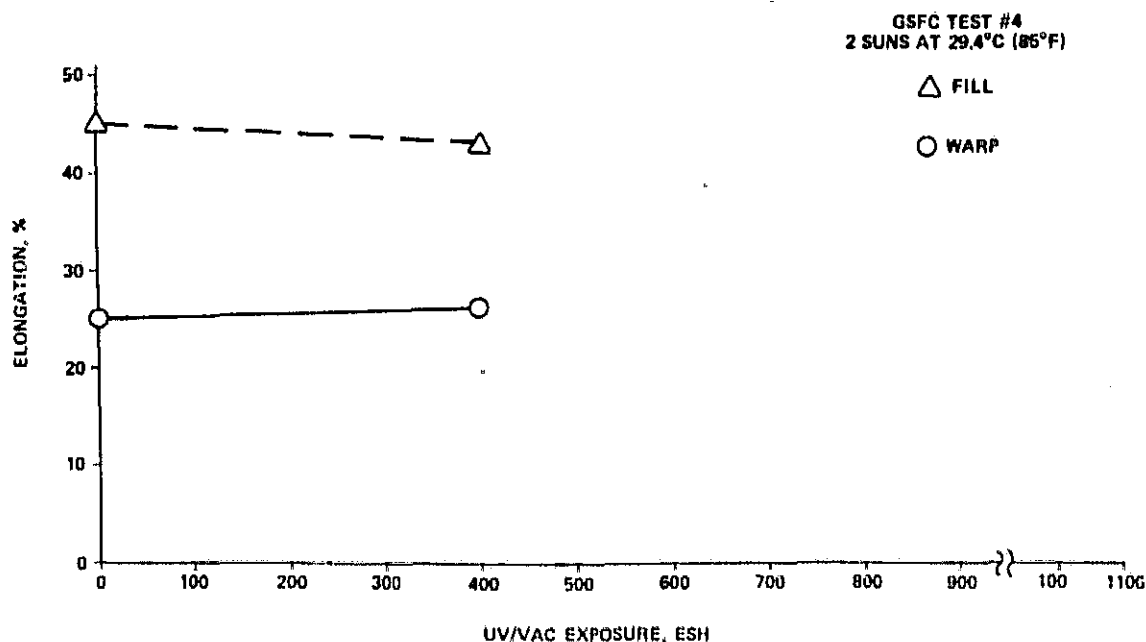
Figures 18 and 19 show the breaking strength and elongation of the MSFC SAIL II material tested to 400 ESH, after which the tests were terminated since no appreciable change was noted.

Figure 18. MSFC SAIL II breaking strength versus UV/vacuum exposure (S-13G to sun).

Figure 19. MSFC SAIL II elongation versus UV/vacuum exposure (S-13G to sun).

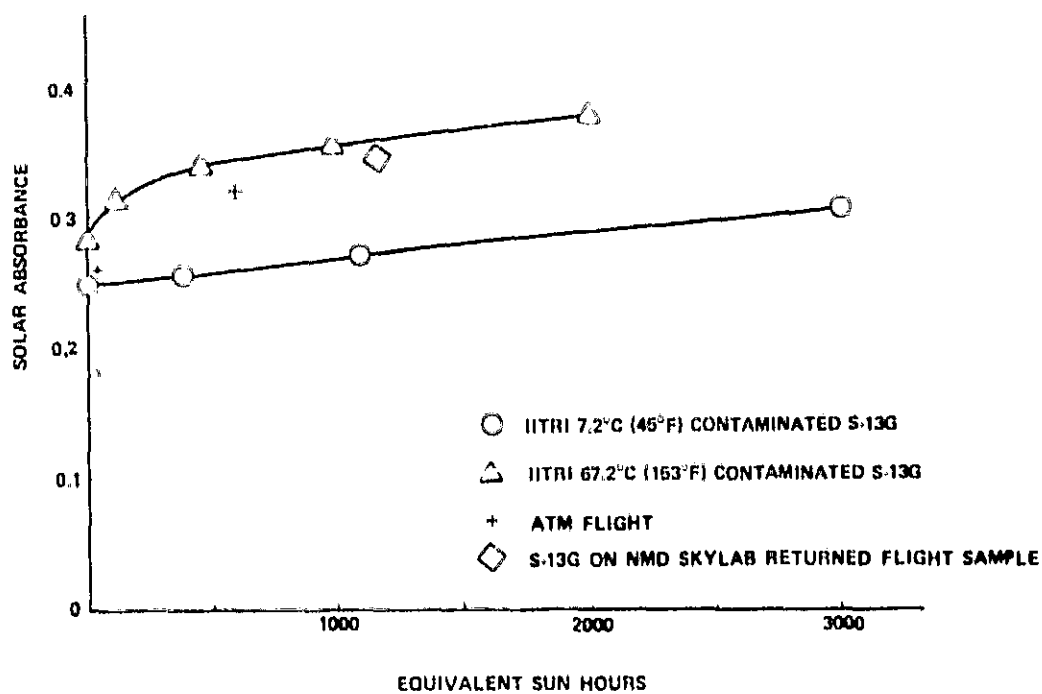
Figure 23. S-13G thermal control material α vs. ESH (ground and flight data).

Figure 23 shows absorbance (α) data from ITRI (Illinois Institute of Technology Research Institute) for contaminated S-13G at 7.2°C (45°F) substrate temperature and 67.2°C (153°F) substrate temperature, some early ATM flight data, and a data point from a Skylab returned sample of S-13G coated NMD material which

had "seen" 1176 ESH in orbit. It is interesting to note that the contaminated S-13G data from the ground testing tracked so well for the S-13G coating on the ATM, and the recovered flight sample. Earlier laboratory data on absolutely clean S-13G material showed very little degradation in 4000 ESH, but all indications are that contamination somewhat influenced the performance of the S-13G on the MSFC SAIL II, as well as other surfaces on Skylab which were painted with S-13G. Fortunately, the thermal performance of the S-13G material was still relatively good in spite of a degree of contamination.
